INSPECTION REPORT: KENSINGTON GOLD MINE

Tongass National Forest Minerals Group
8510 Mendenhall Loop Rd
Juneau, AK 99801
(907) 789-6276 – office
(907) 586-8808 – fax

Date of Inspection: Wednesday, May 11, 2022
Date of Report: Thursday, May 26, 2022
USDA Forest Service Inspector: Casey Loofbourrow

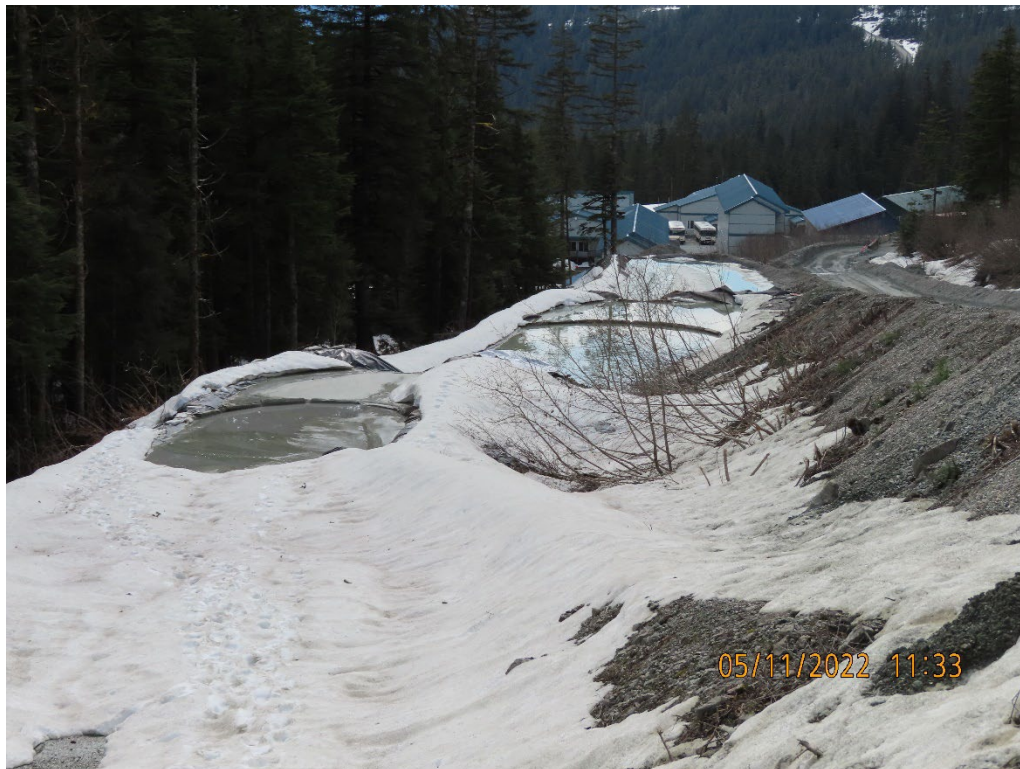
Photo 1. Wolf Coarse Sediment BMPs.

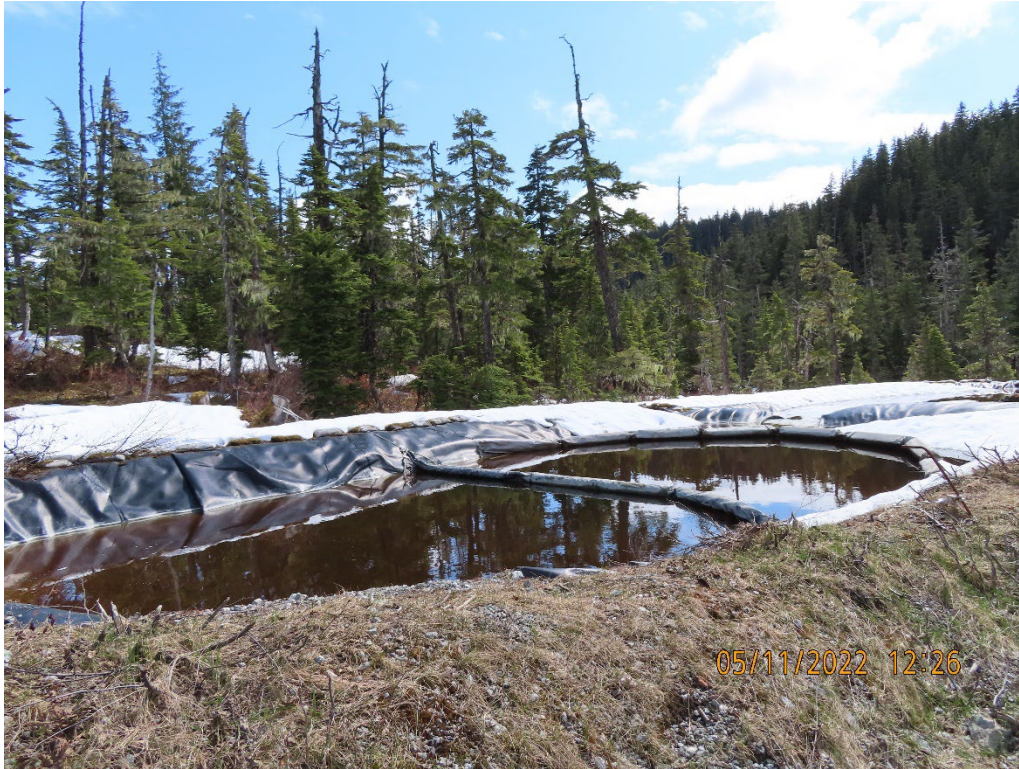
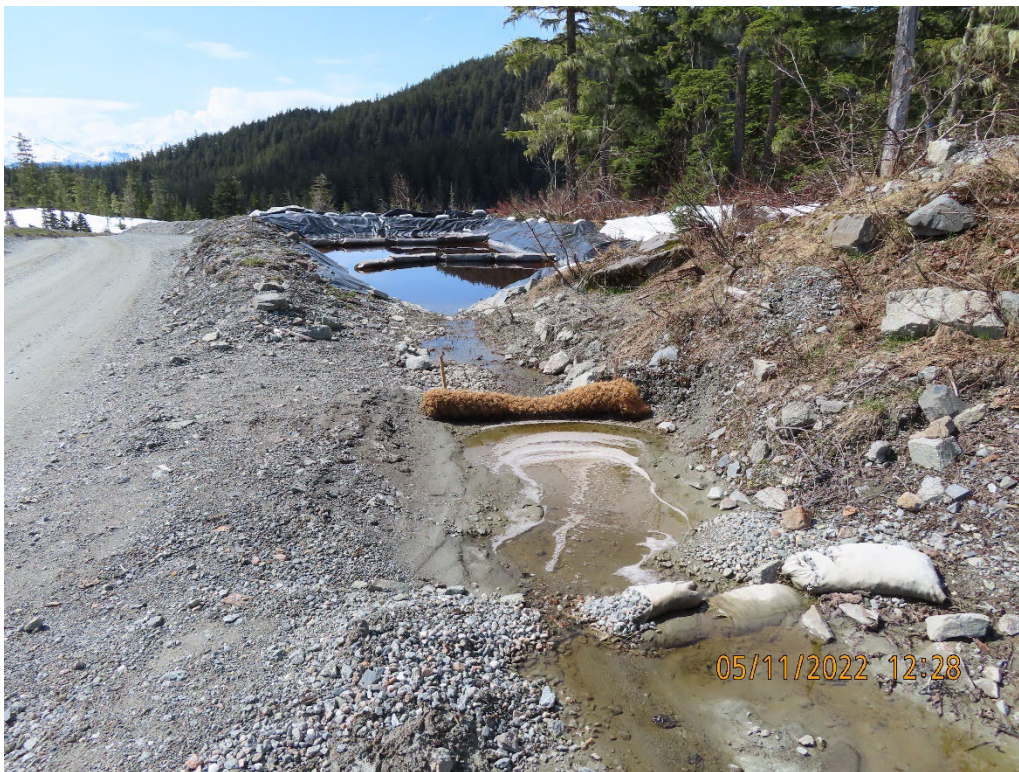
Photo 2. TTF access road stormwater BMP.

Photo 3. TTF access road stormwater BMP.

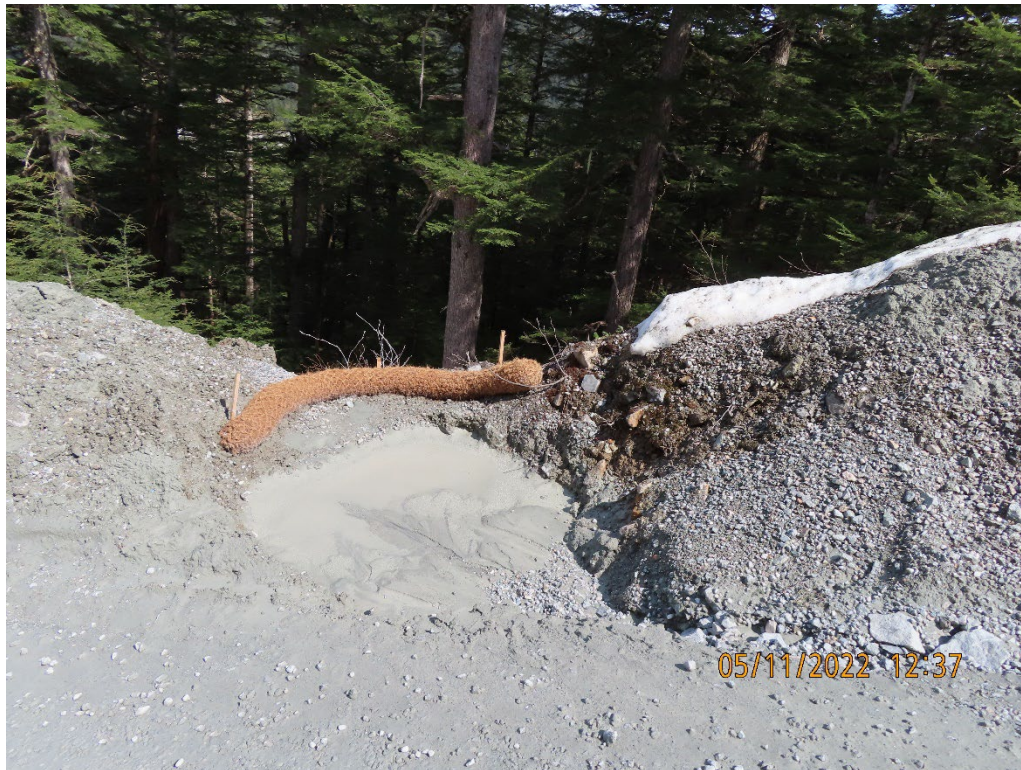
NEW ACTION ITEM 189-1: Along the TTF Access Road, there are several stormwater BMPs (Photos 4-6) designed to capture fine sediments transported by flow along the road surface. It appeared the sediments removed from these sumps were mucked onto the adjacent road berms. This practice puts fine sediments in a location where they will readily be transported back onto the road surface and into the BMPs, increasing the necessary maintenance frequency of these BMPs. It is recommended that Coeur dispose of these sediments in a more permanent manner in an authorized location to increase the long term effectiveness and reduce the required maintenance of these BMPs.

Photo 4. TTF access road stormwater BMP. Fine sediments mucked from sump are visible on the left of the photograph.

NEW ACTION ITEM 189-1: Fine sediments mucked from TTF Access Road BMPs should be permanently disposed of in an authorized location, i.e., underground.

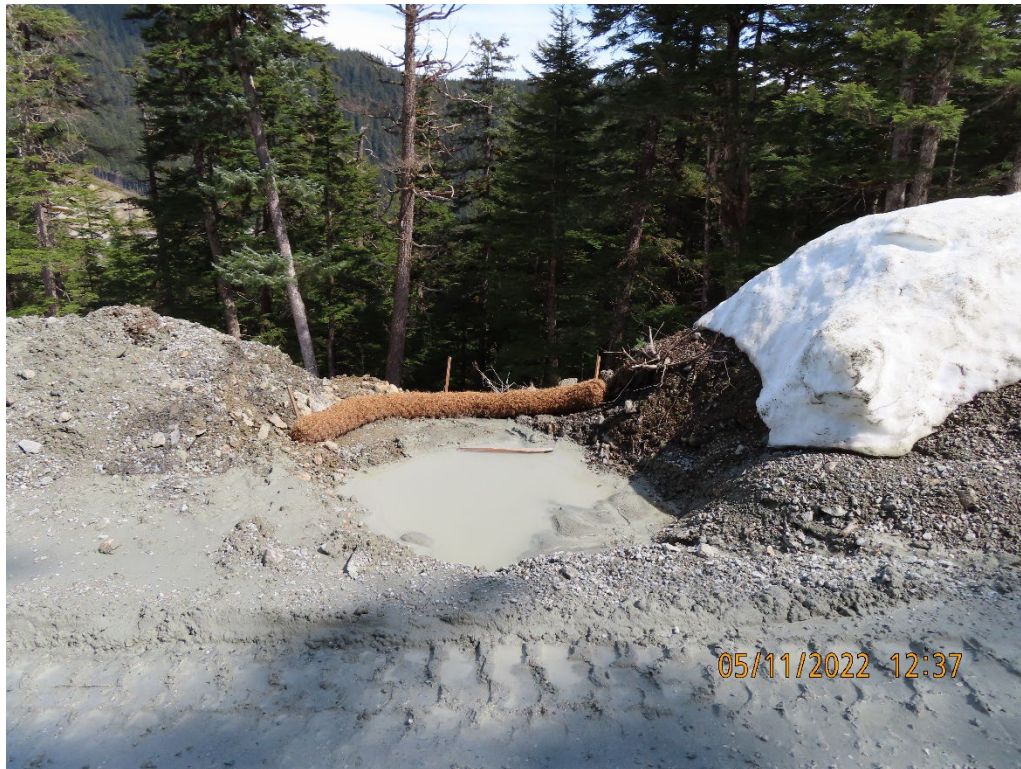
Photo 5. TTF access road stormwater BMP.

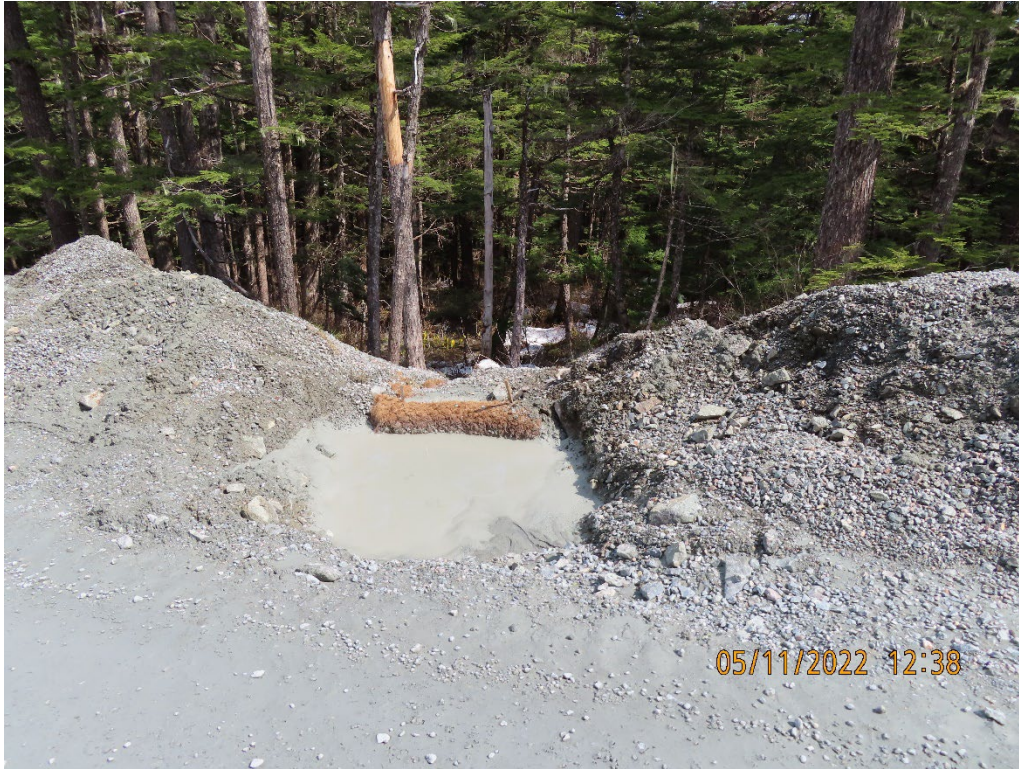
Photo 6. TTF access road stormwater BMP. Fine sediments mucked from the sump are visible to the left of the photograph.

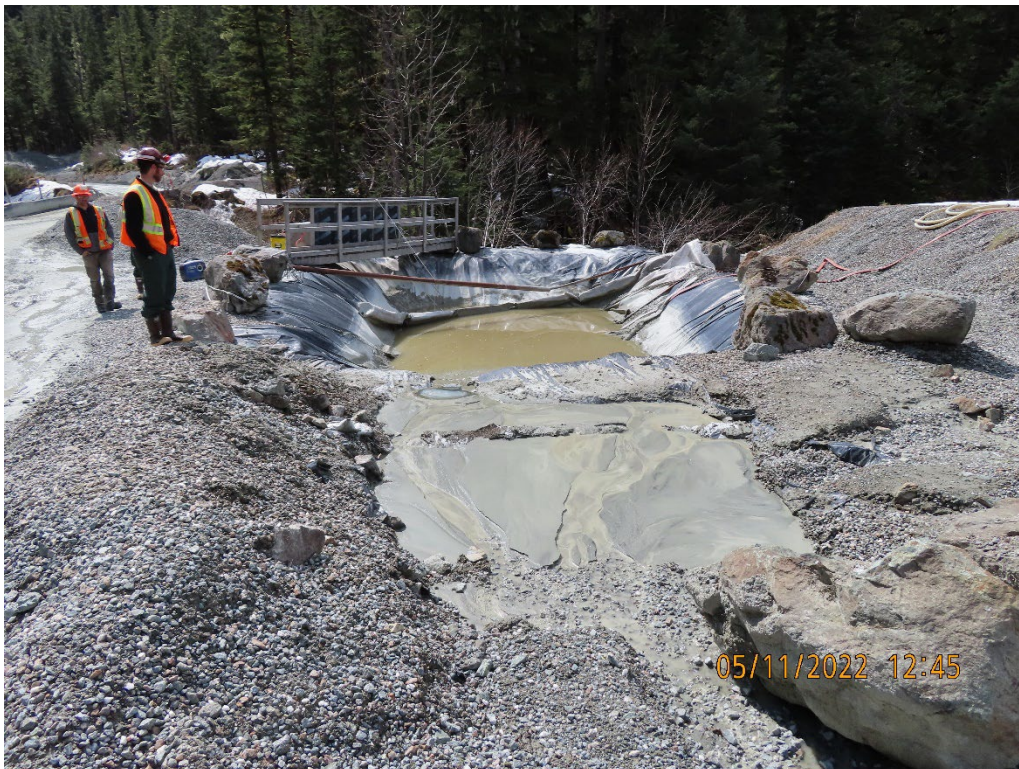
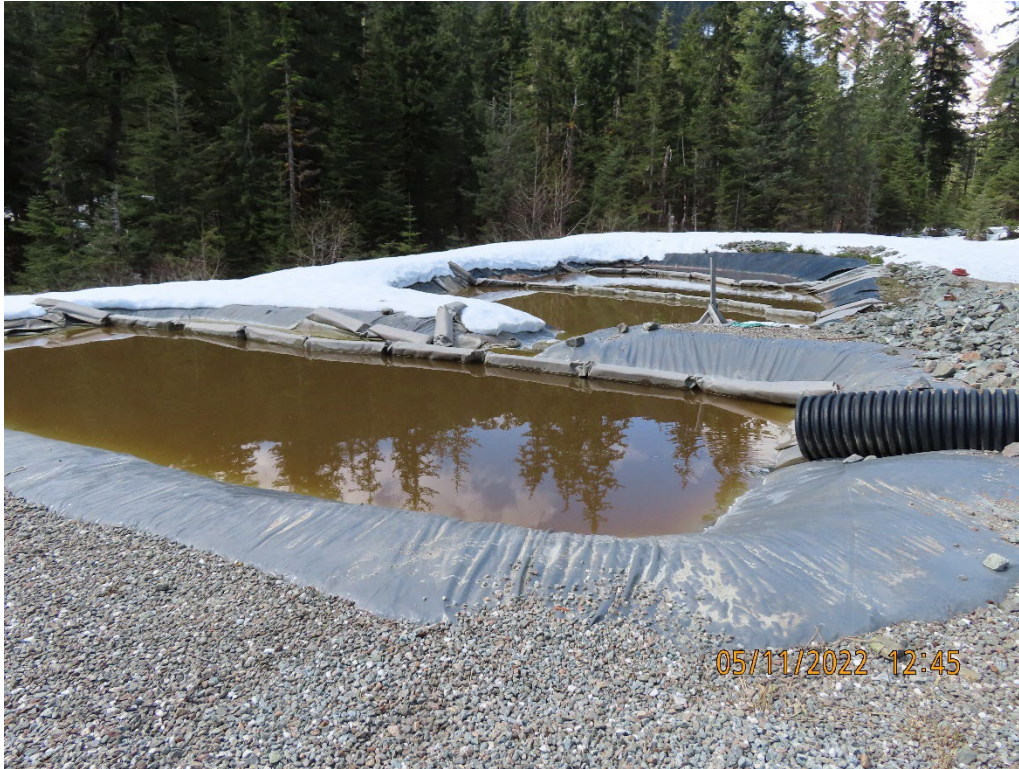
Photo 7. Bridge 2 stormwater BMPs.

Photo 8. Bridge 2 stormwater BMPs.

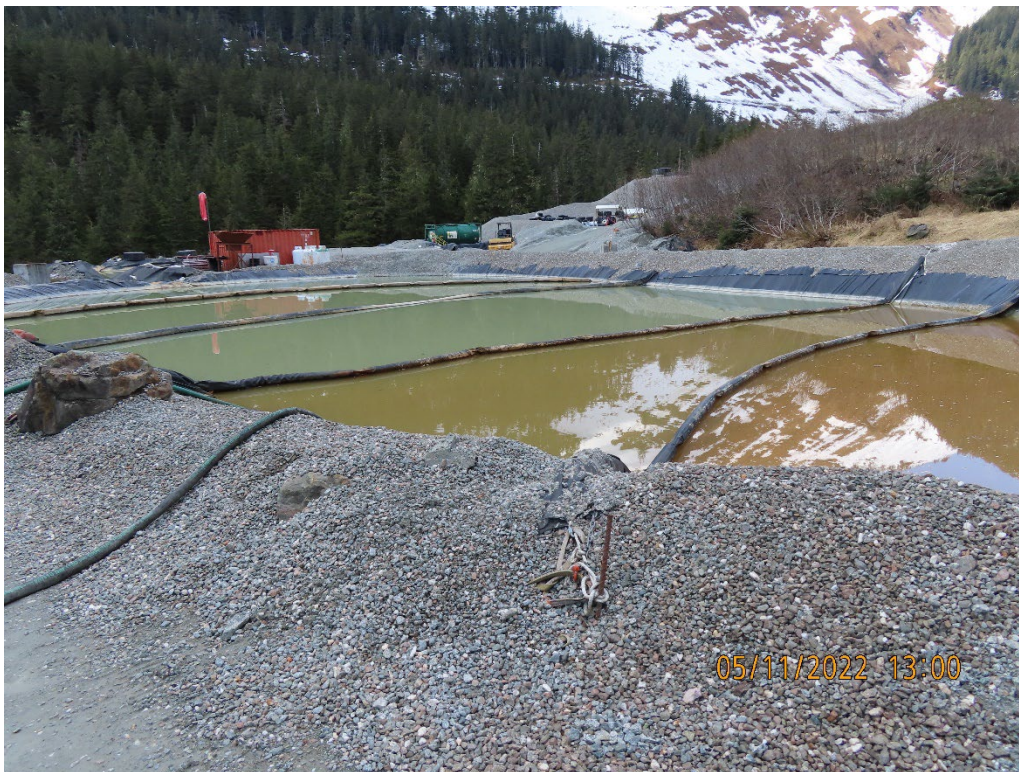
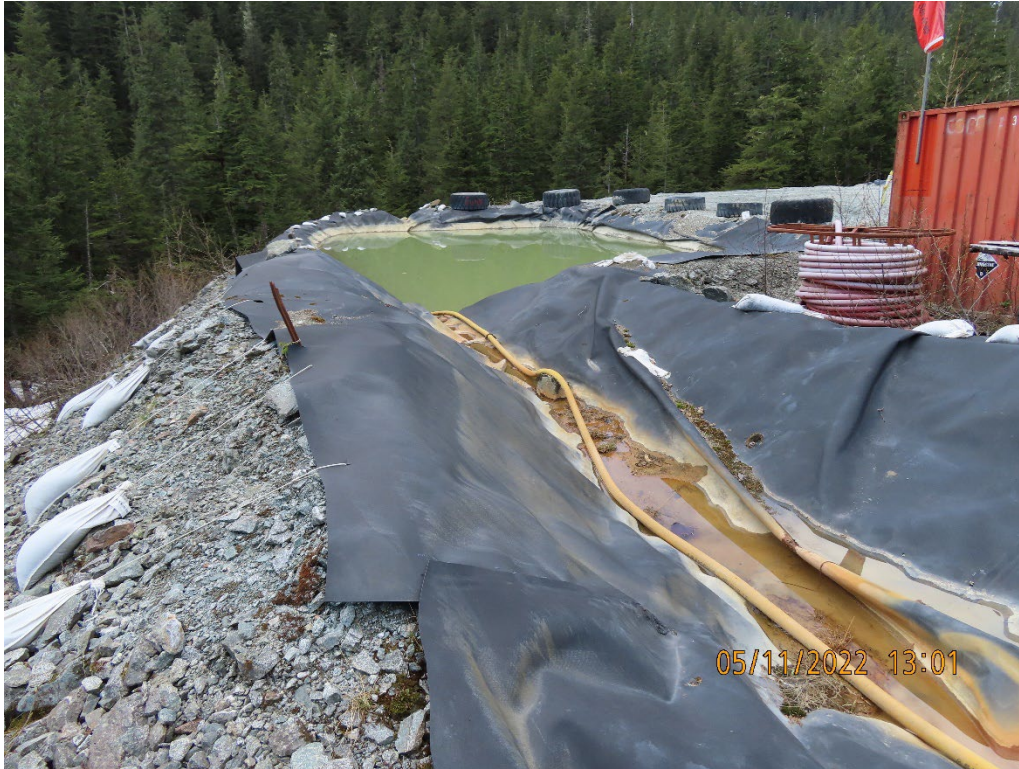
Photo 9. Mud dump stormwater BMPs.

Photo 10. Mud dump stormwater BMPs.

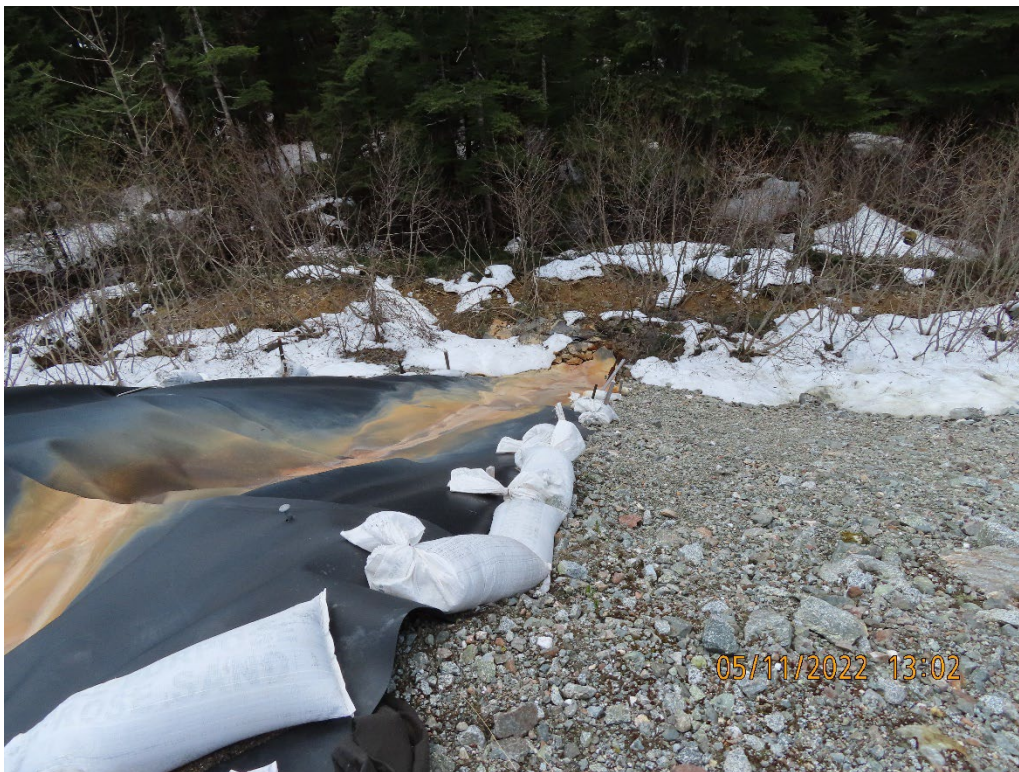
Photo 11. Mud dump stormwater BMP outfall.

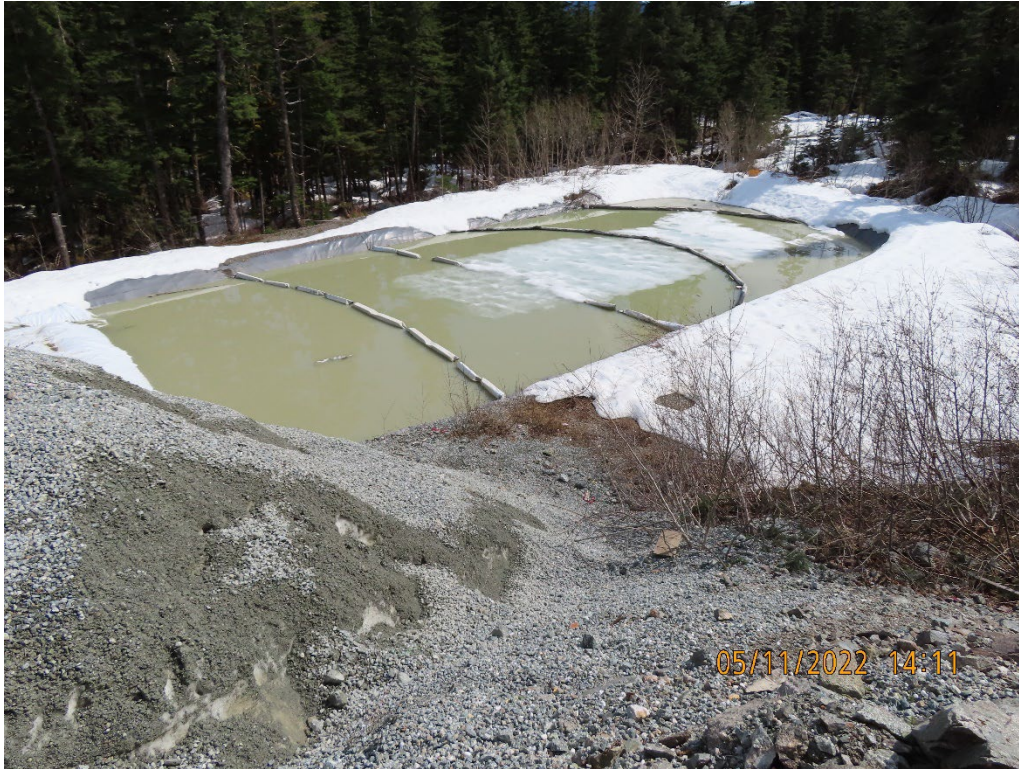
Photo 12. Lower laydown area stormwater BMPs.

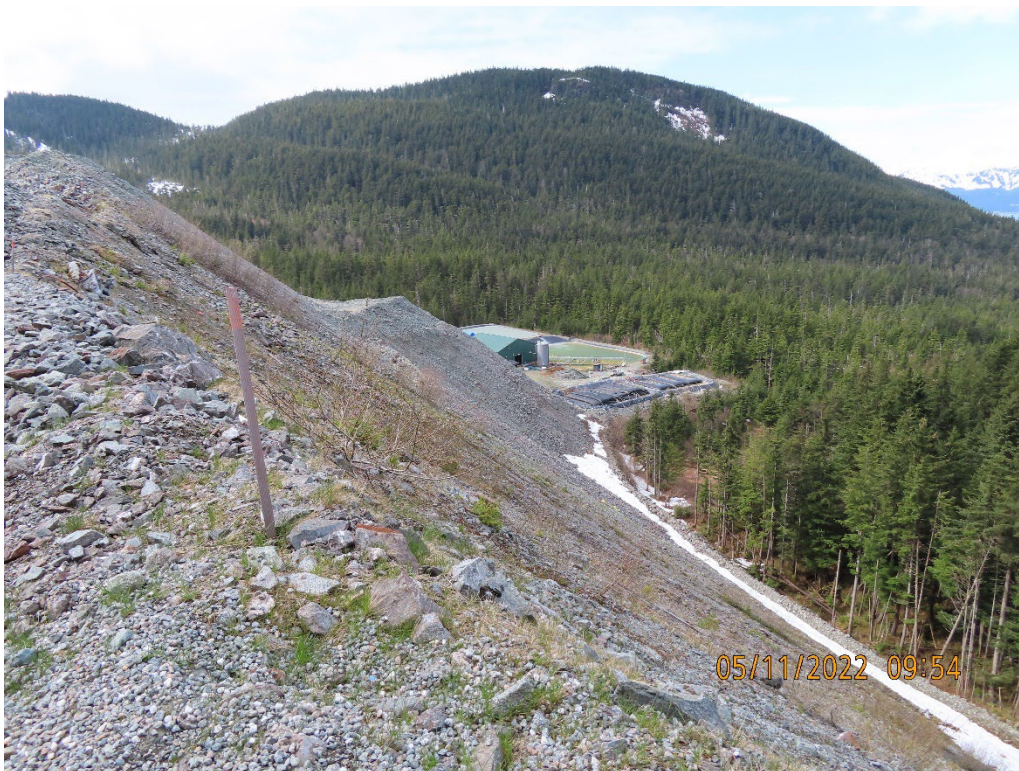
The slopes of the Comet waste rock storage area appear stable (Photo 13). There has been no recent waste rock placement at this site.

Photo 13. Comet waste rock storage area.

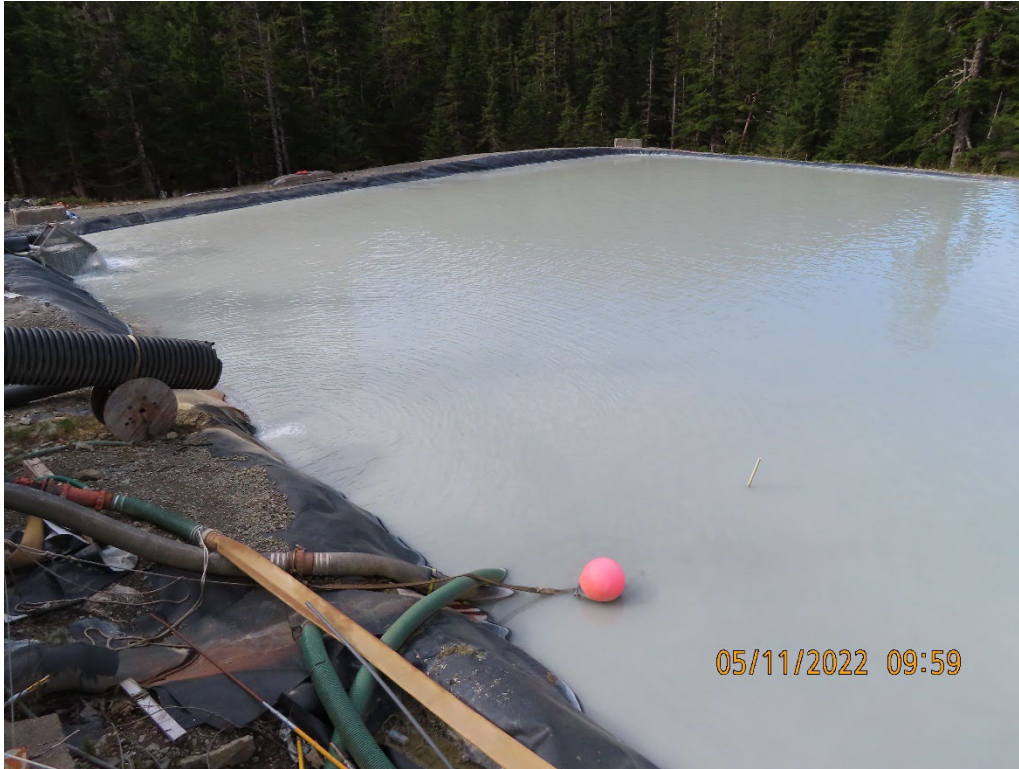
The CWTP was treating approximately 1,640 gallons per minute (gpm). During the site visit, Pond 1 (Photo 14) was receiving water from the underground mine and Pond 2 was being dredged (Photo 15).

Photo 14. Comet WTP Pond 1.

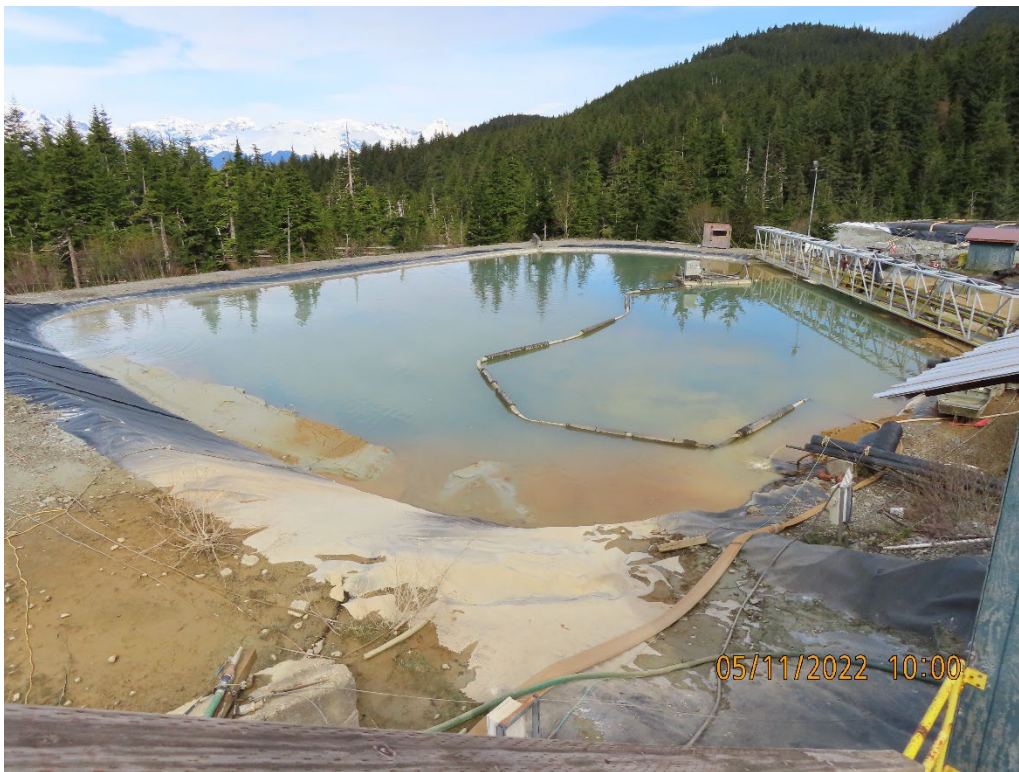
Photo 15. Comet WTP Pond 2.

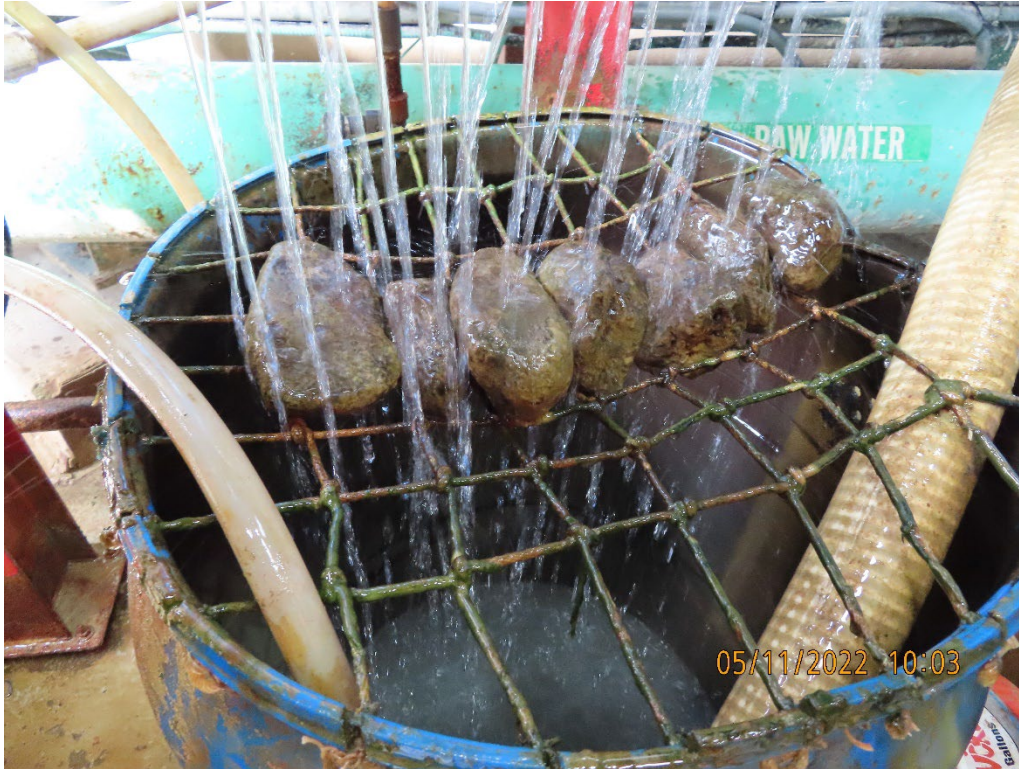
White material was not observed on the test rocks used for monitoring in the CWTP (Photo 16). Coeur continues to add Z-Clear flocculant into the underground sumps in an effort to facilitate removal of drill

Photo 16. Comet WTP white material test rocks.

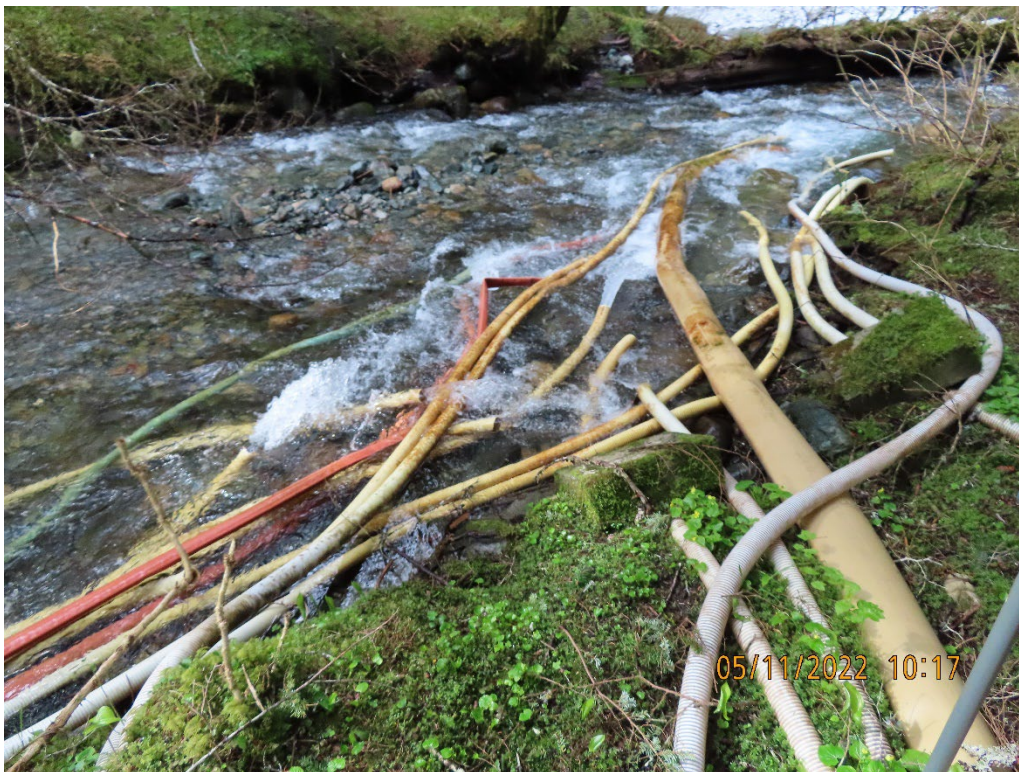
No white material was observed at Outfall 001, where treated water from the CWTP is discharged through a manifold and multiple outlet hoses (Photo 17).

Photo 17. Outfall 001 Sherman Creek.

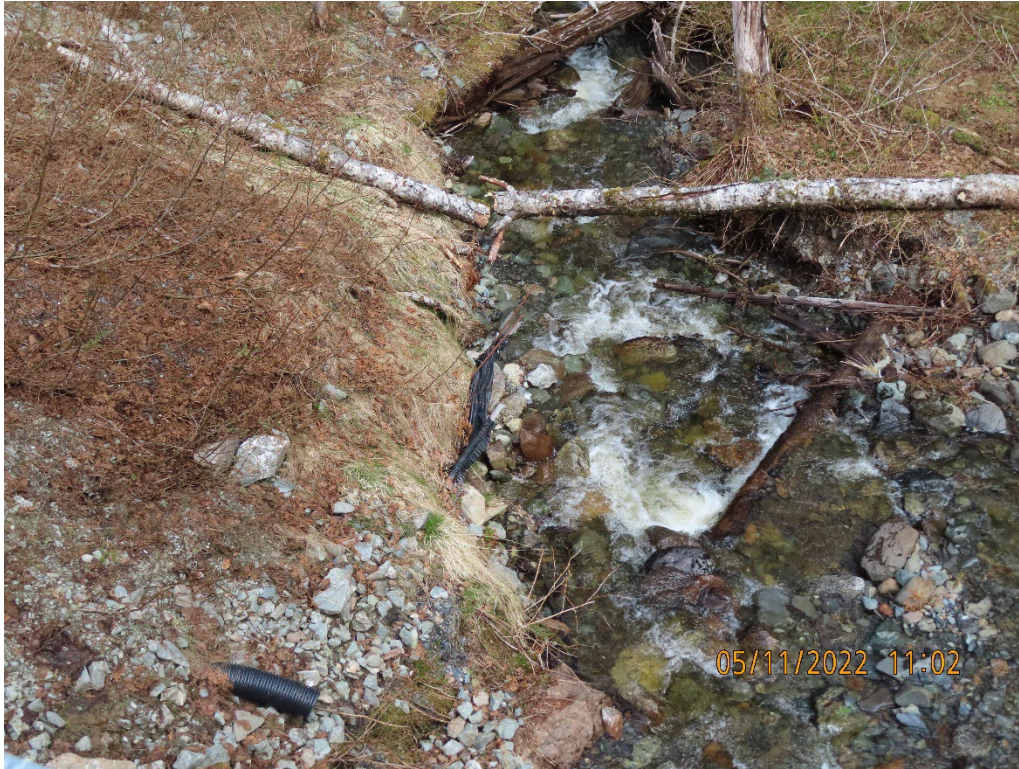
NEW ACTION ITEM 189-2: Silt fencing is present at both bridges (Photos 18-19). This fencing was installed during construction activities to reduce fine sediment discharge to the streams. The stream banks appear stabilized and/or revegetated to the extent that the silt fencing no longer serves a beneficial purpose and could become a source of debris if left in place. The silt fencing should be removed and disposed of.

Photo 18. No Name Creek and silt fencing that should be removed.

NEW ACTION ITEM 189-2: Silt fencing below the No Name Creek and Upper Sherman Creek bridges should be removed.

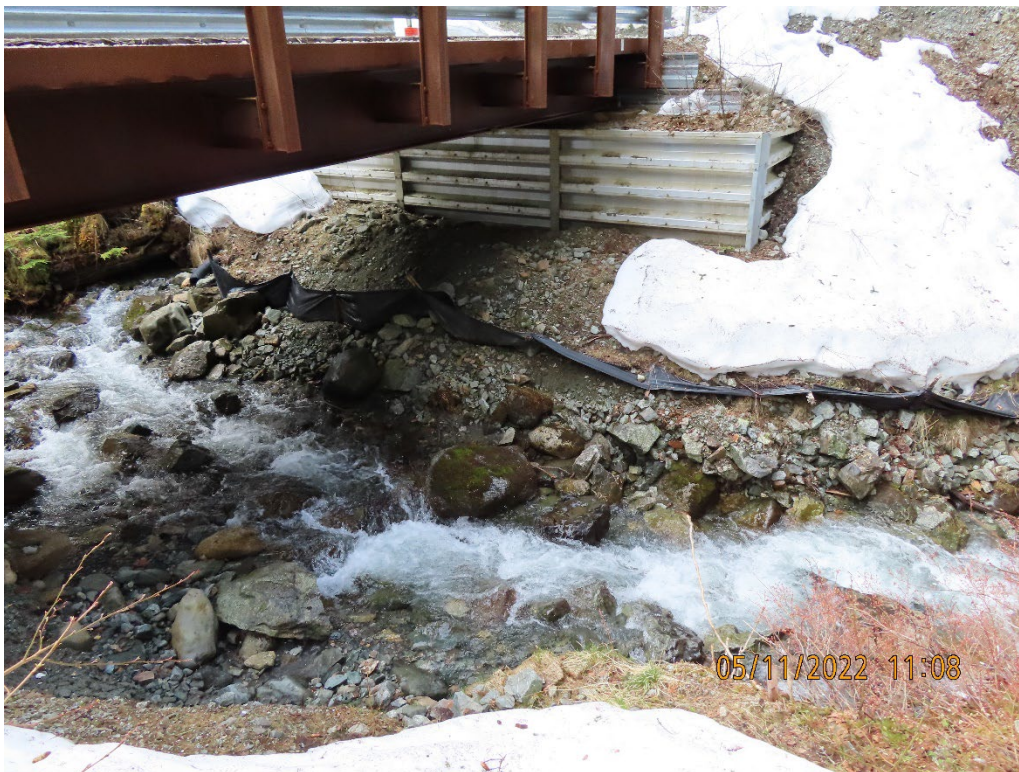
Photo 19. Sherman Creek Bridge and silt fencing that should be removed.

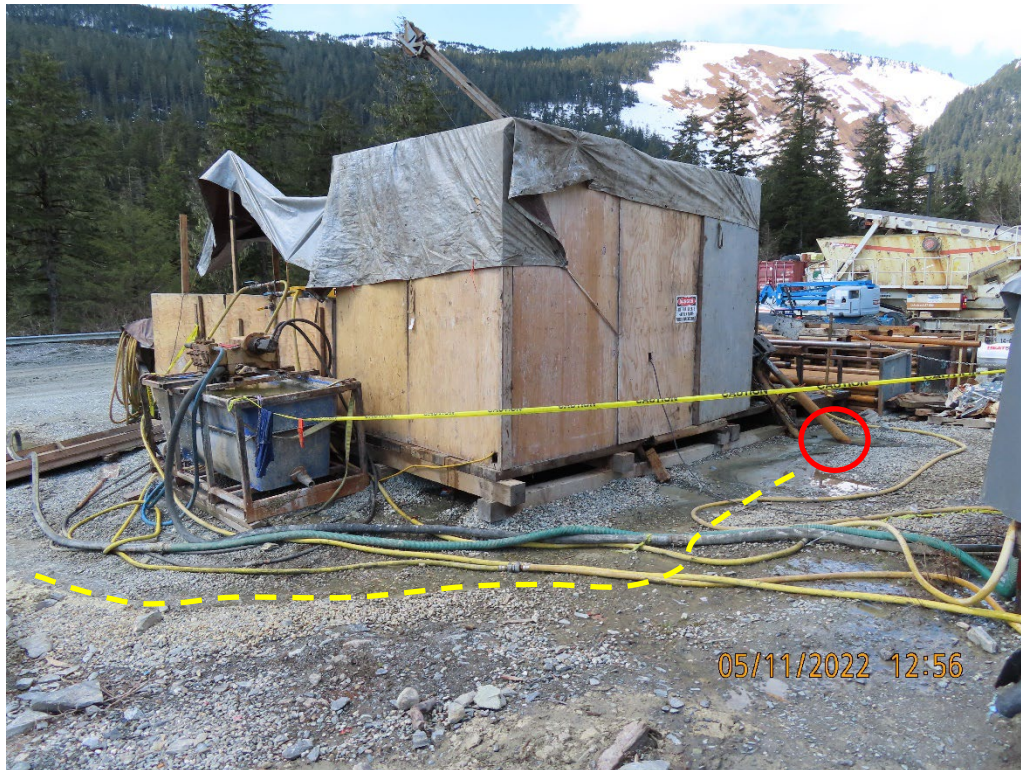
NEW ACTION ITEM 189-3: Diamond core exploration drilling is currently being conducted in Pit 4 (Photo 22). The drill hole appears to have intercepted groundwater which is discharging to the surface. Coeur should ensure that drill hole(s) are reclaimed and plugged in compliance with 18 AAC 80, and the "Alaska Best Management Practices, for Maintaining or Decommissioning Water Wells and Boreholes", which includes measures specific to holes that encounter artesian flow. This location will be monitored until it has been documented that the surface flow from the borehole has ceased.

Photo 22. Drill Rig at Pit 4. Drill collar is indicated by red circle. Water emanating from drill hole and flowing over surface denoted by dotted yellow line.

NEW ACTION ITEM 189-3: Surface flow from exploration drill hole should be appropriately mitigated.

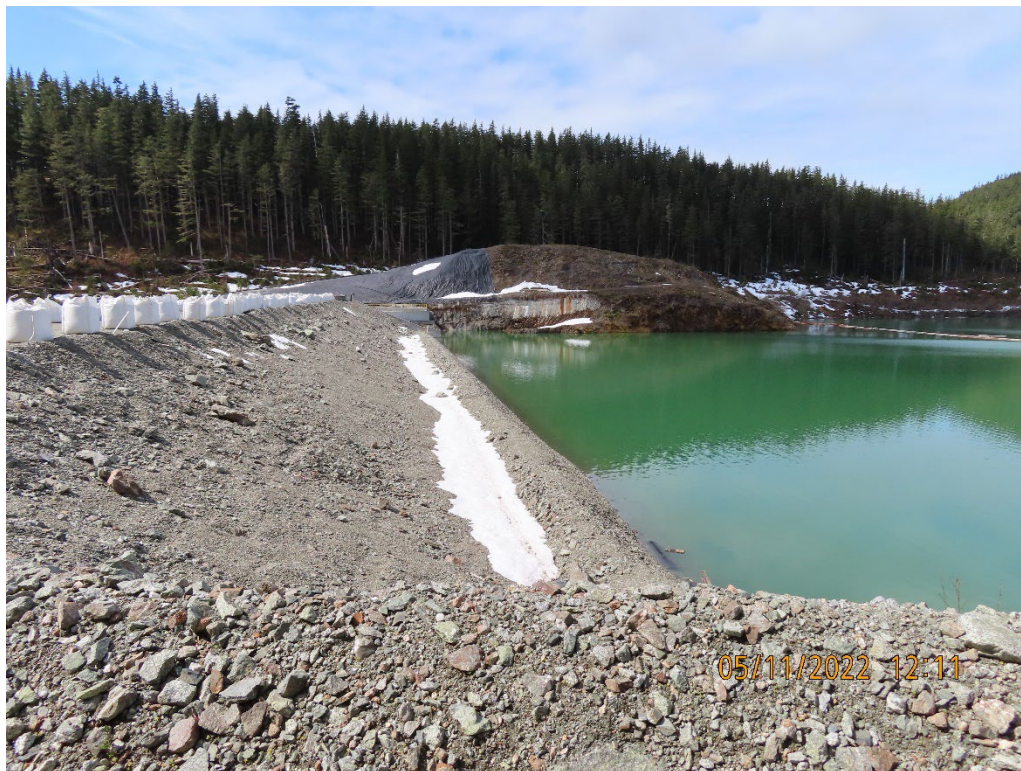
The TTF has mostly thawed, and tailings were being deposited in the northeast area of the TTF. The TTF dam face was free of debris (Photo 25).

Photo 25. TTF dam face.

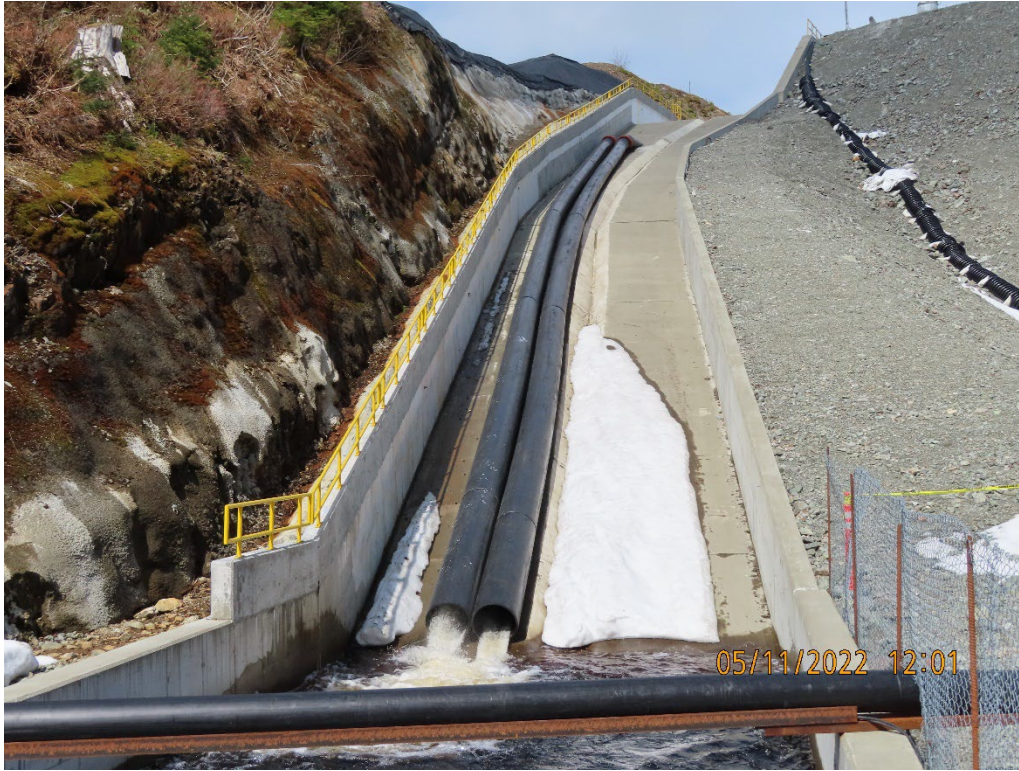
The TTF dam spillway did not appear to have been contacted by ARD drainage from the adjacent graphitic phyllite bedrock (Photo 26). In 2021 Coeur completed construction of a concrete raise to the edge of the spillway in an effort to capture and direct ARD to the seepage collection sump where it is transported to the ARD Seep WTP.

Photo 26. TTF spillway, showing lack of ARD incursion beyond the new raise.

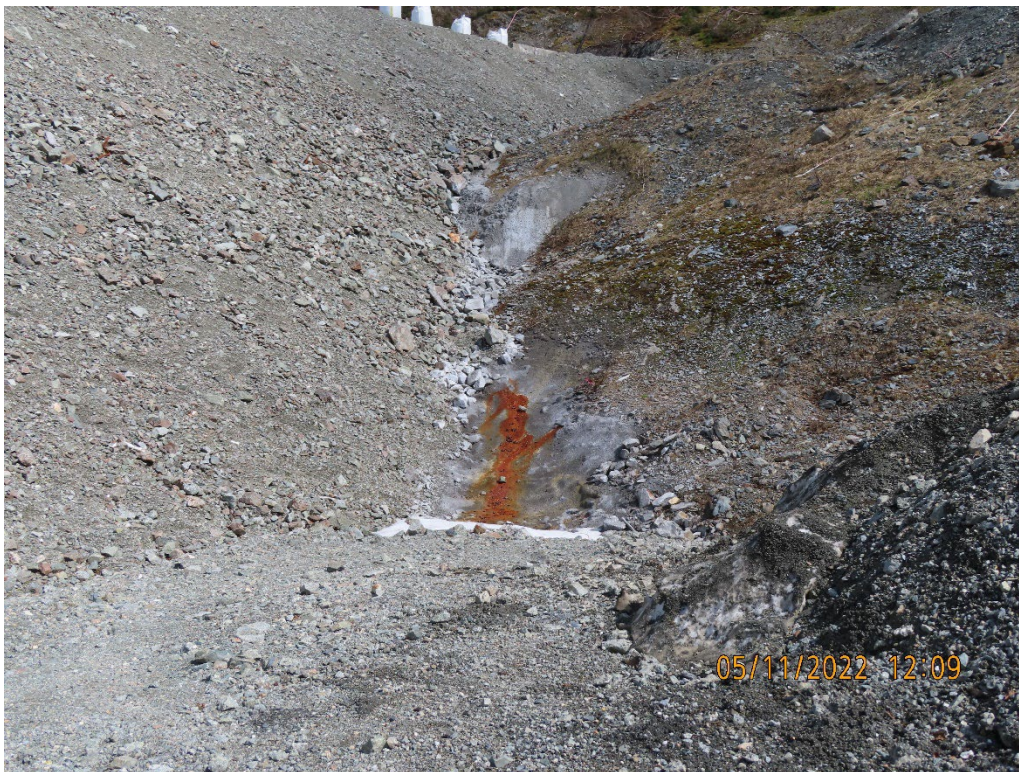
Pending action item 183-2: This area has recently been uncovered by melted snow. ARD seepage is still visible (Photo 27). This seepage is ultimately collected and treated at the Seep Water Treatment Plant,

but Coeur plans to shotcrete this area to minimize oxidation of the ARD-generating outcrop out of an abundance of caution. No impacts to the environment are expected from this seep.

Photo 27. ARD seep near east buttress of TTF Dam.

ID	Action Item	Status
183-2	ARD seepage at the TTF SE abutment.	Pending. This site was recently exposed by snow melt and Coeur plans to apply shotcrete in the

near future to reduce oxidation of the ARD-producing outcrop. ARD generated at this location is collected and treated at the Seep Water Treatment Plant.
188-1	Kensington access road guard rails are damaged and need to be replaced.	Pending. Coeur plans to fix guardrails once materials are available.

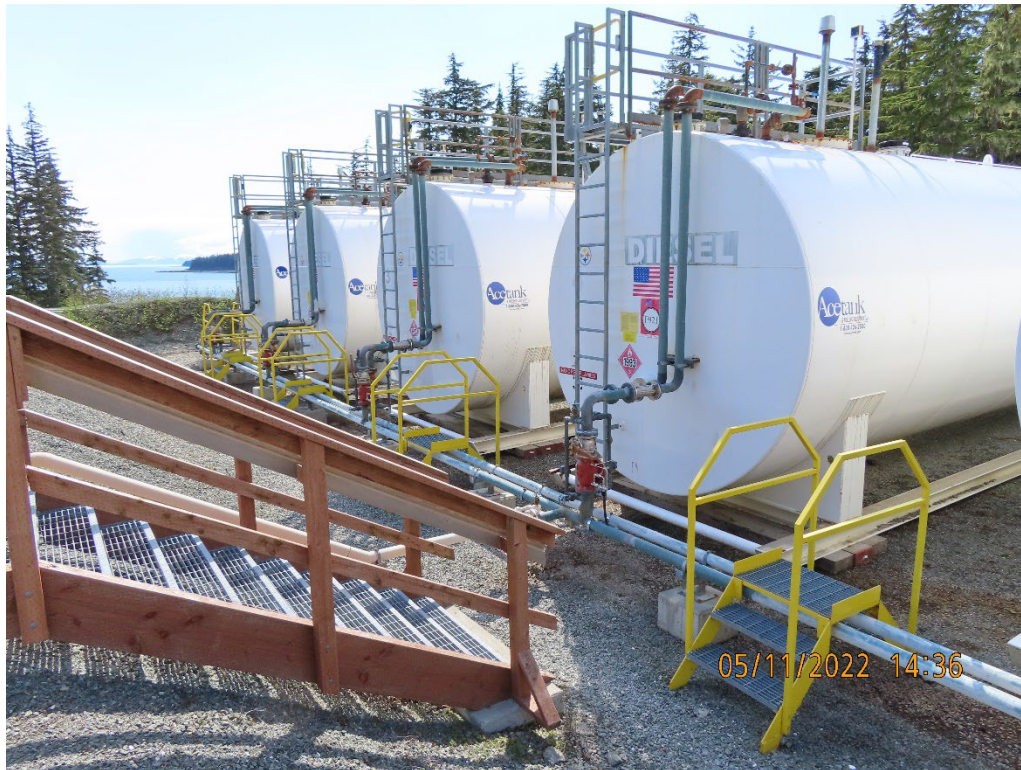
The fuel depot was in good condition with no sheen or spills observed (Photo 28).

Photo 28. Fuel depot.

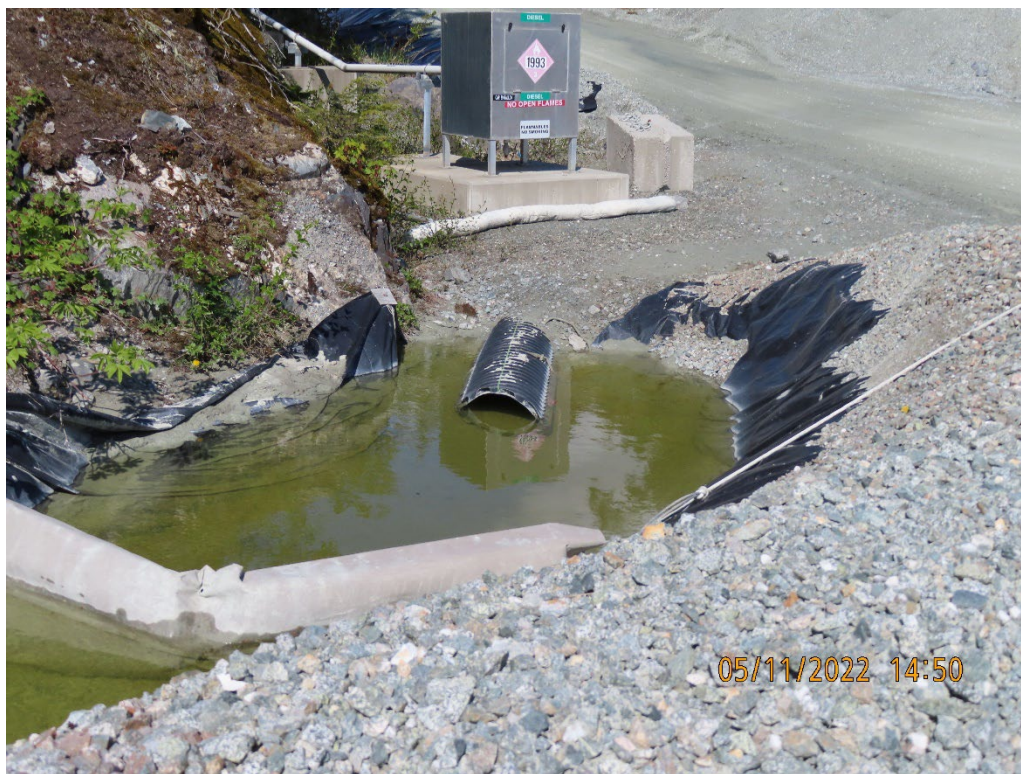
The stormwater BMPs at the marine port facility were functioning as intended. A culvert identified as needing sediment removal in the previous inspection has been cleaned and is in good condition (Photo 29). Flocculant logs were placed in the ditch to promote settling of suspended sediments from surface runoff (Photo 30) and appeared to be effective as minimal turbidity was observed near the discharging end of the BMPs.

Photo 29. Slate cove marine facility BMP culvert that was noted as in need of sediment removal in previous inspection.

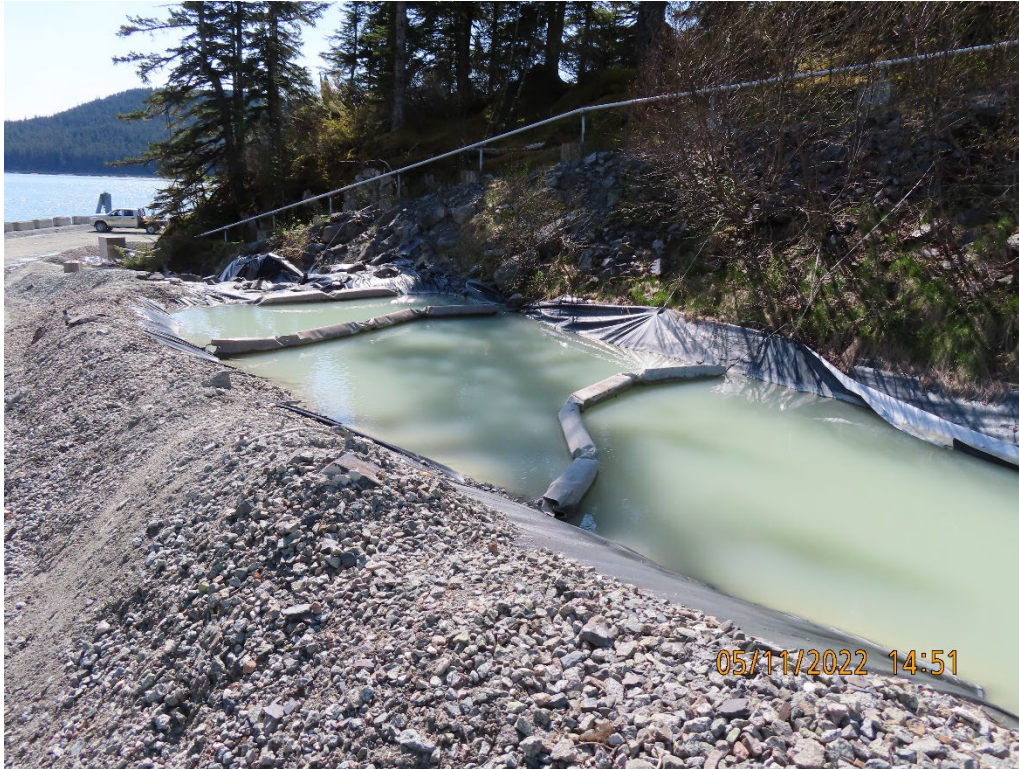
Photo 30. Slate cove stormwater BMPs.
